Management of Implant-related Problems and Infections

Abstract

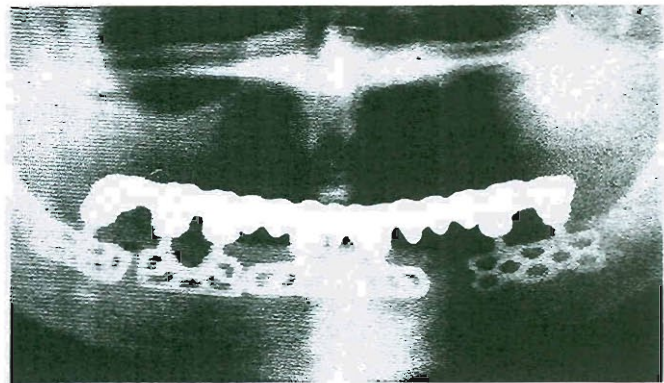
Figure 6. A panoramic radiograph of the completed case shown in Figs. 4 and 5.

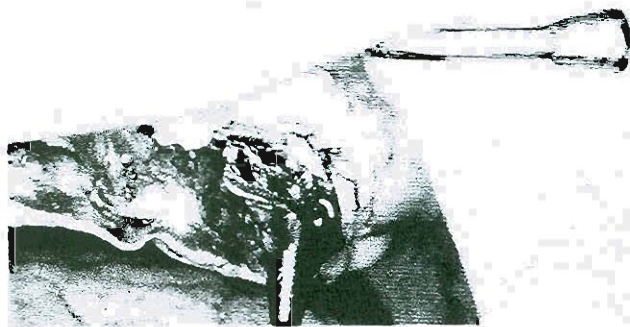
Figure 16. Case 2: With the abutment adjusted for parallelism, the blade implant is placed in the anterior osteotomy.

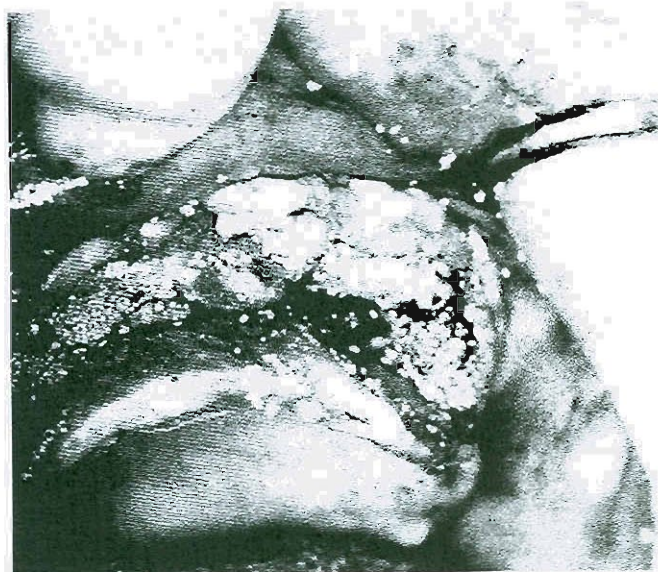
Figure 17. Case 2: The implant osteotomies and bony defects of the alveolar ridge are grafted with resorbable hydroxylapatite to restore ridge architecture.

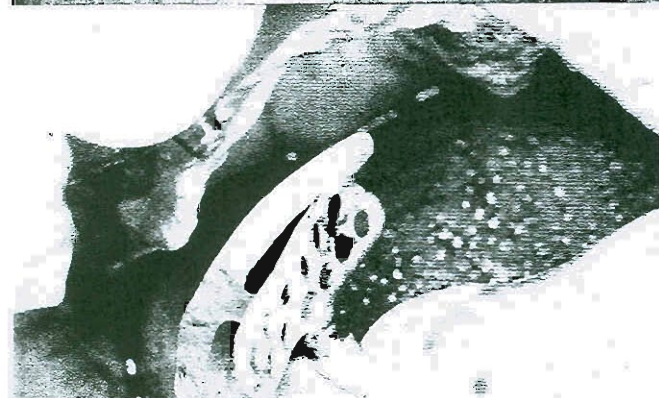
Figure 18. Case 2: The prosthetic abutments are affixed to the anterior blade implants at second-stage surgery, and a unilateral subperiosteal implant with a broad fenestrated palatal strut is inserted posteriorly.

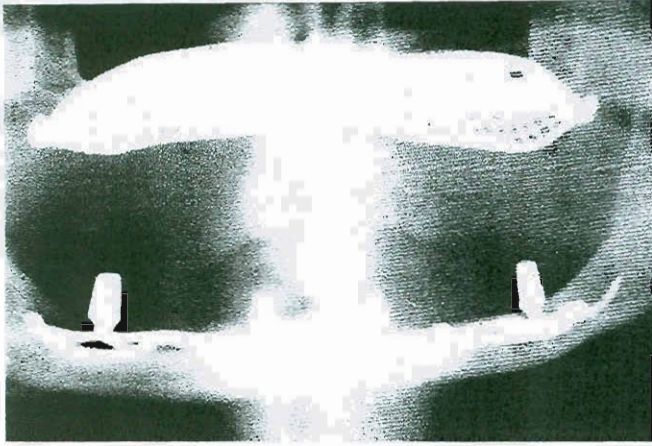
Figure 20. Case 3: Pre-operative radiograph reveals settling of the lower right posterior third and bone resorption beneath the left posterior abutment of an 11-year-old mandibular subperiosteal implant. The anterior segment of the implant remains normal and free of any problem.

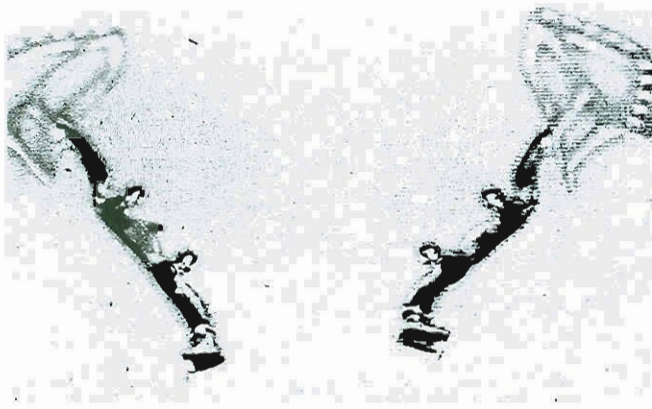
Figure 22. Case 3: New posterior subperiosteal implant segments with ramus and horizontal anterior extensions bearing O-ring attachments are fabricated. These units are designed to telescope over the distal extensions of the cast anterior copings.

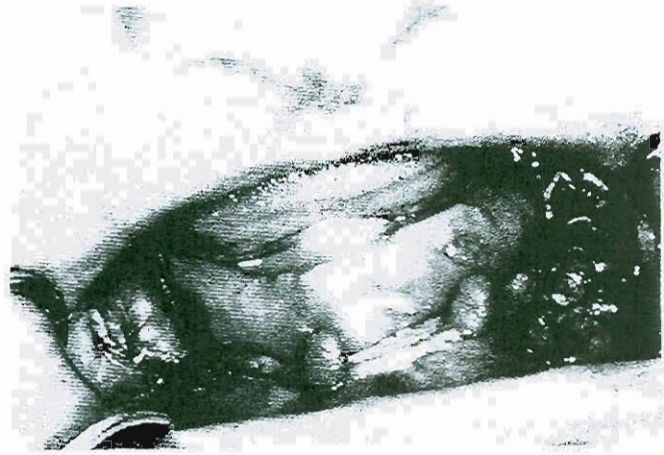
Figure 21. Case 3: Duralay patterns for copings are placed on posts of the anterior segment of the existing implant and are picked up with posterior subperiosteal impressions in a final pick-up full-arch impression.

implant that had been permitted to remain (Fig. 21). Two unilateral subperiosteal implants were designed that covered the rami and had anterior horizontal bars with O-ring mesostructures. The most anterior portions of both castings were hollow. This allowed them to house the distally extended horizontal extensions which protruded directly from the anterior copings (Figs. 22-24). These were later cemented over the anterior subperiosteal implant abutments and locked into the posterior horizontal extensions (Fig. 25). In this manner, the posterior occlusal forces were dissipated *via* the mesostructure to the unilateral subperiosteal implants (Figs. 26, 27).

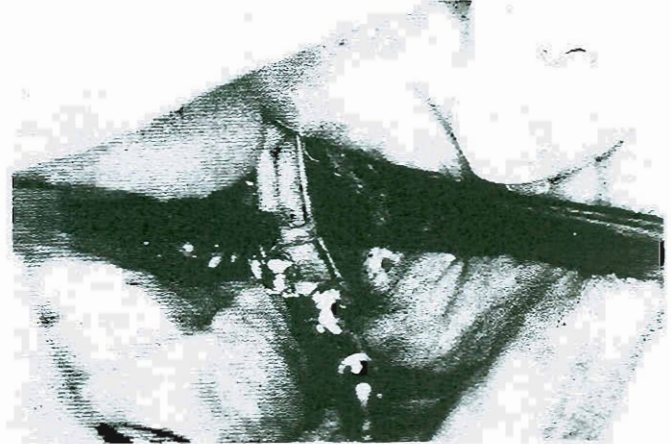
Figure 25. Case 3: The left implant is seated on the ramus with its tubular section engaging the anterior coping. The tubular sections are cemented in place.

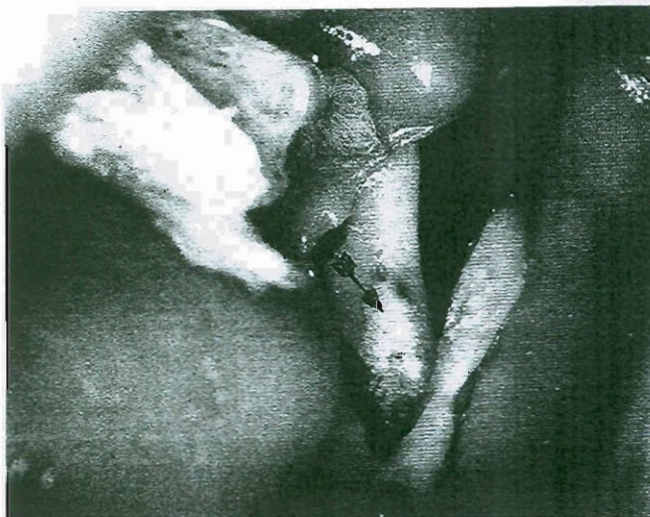
Figure 30. Case 4: The subperiosteal posterior section was removed, and the area of bone resorption was debrided of all granular tissue, revealing a dehiscence of the inferior alveolar canal 1 cm in length at the area of the distal post. The dehiscence was covered with resorbable HA, venous blood, and a collagen hemostatic matrix (arrow).

One month later, the site was re-opened, and the graft was found to be firm but not ossified (Fig. 30). A new posterior subperiosteal implant section had been designed to by-pass the healed defect, with the new load-bearing ramus abutment placed at the retro-molar triangle (Figs. 31, 32). After the new implant section was seated passively, the new mesostructure was connected to the existing im-

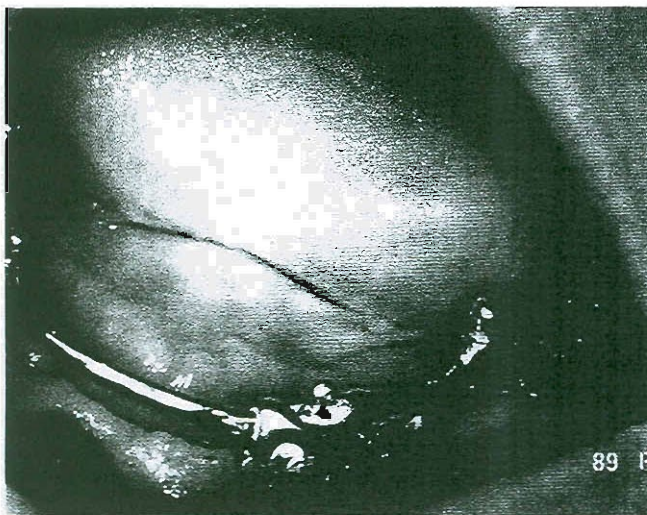
Figure 34. Case 4: The cemented tapered pins are cut flush buccally and lingually. Closure is made with chromic gut sutures.

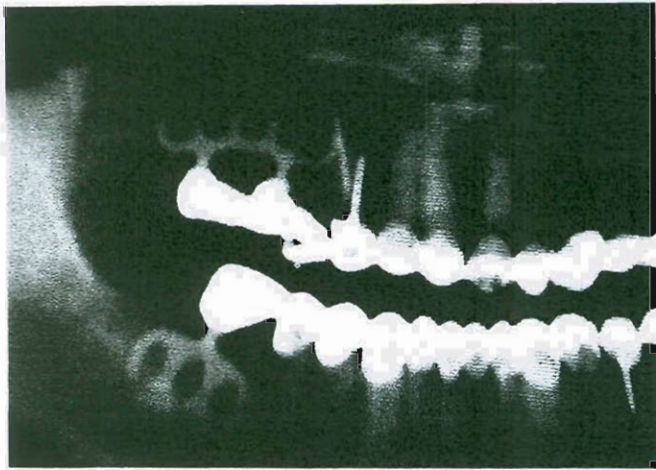
Figure 36. Case 5: Pre-operative Panorex showing failure of maxillary right blade implant after 11 years in function. A full-arch splint was sectioned at the distal of the right canine for endodontic therapy and endodontic post on the canine. The endodontic post perforated the canine root, and the posterior bridge section was not rigidly reconnected. A large bony defect resulted from failure of the canine and the overloaded posterior implant.

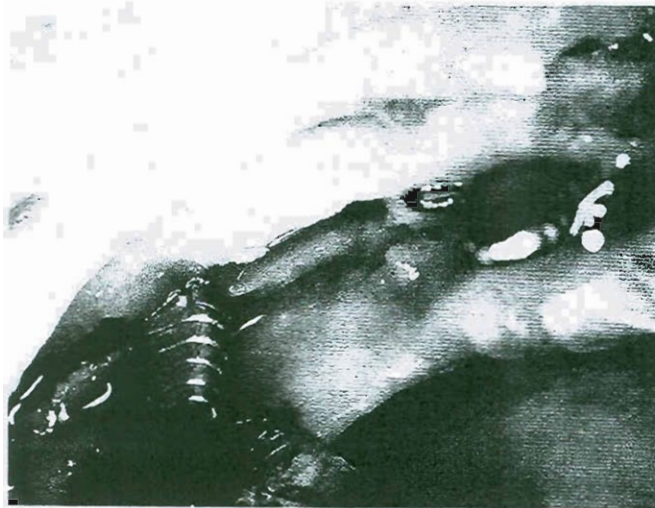
Figure 38. Case 5: Blade implants are seated in regenerated bone of the grafted area shown in Fig. 37.

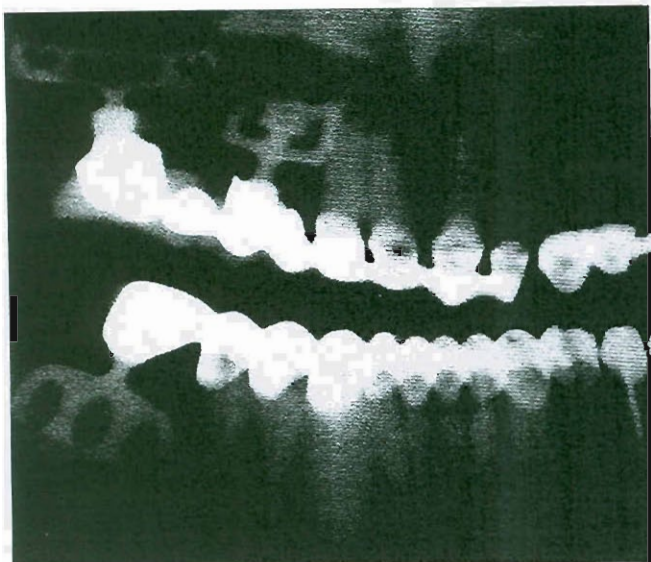
Figure 40. Case 5: Post-operative Panorex illustrating bridge shown in Fig. 39.
